Manhole Inspection Summary

Manhole # S33KK_042MH

Insp Date: **12/6/06 9:07 AM**

Location Address: **10 NORTH AVE**

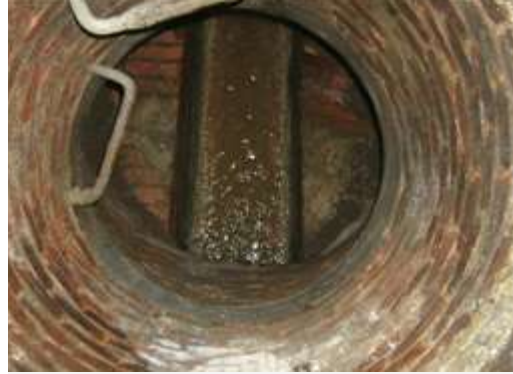
Top View

Corroded steps. Evidence of surcharge - Bench debris.

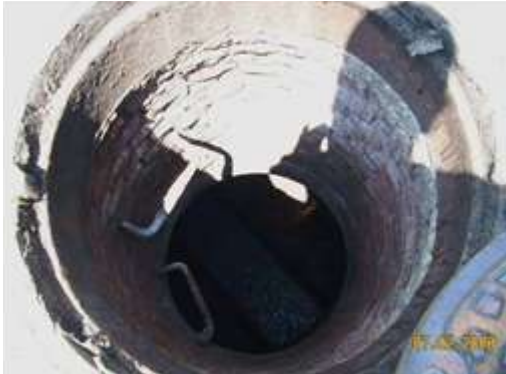
Defect

Frame leaks. Adjustment deterioration and infiltration. Corbel and Barrel infiltration - other side.

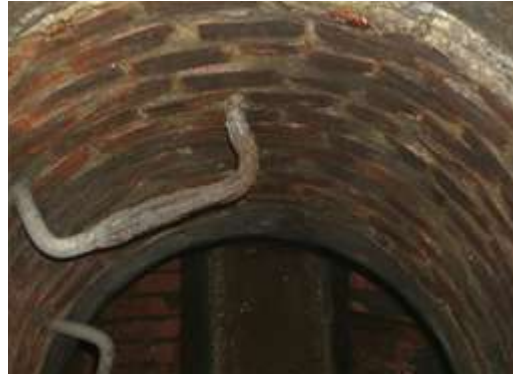
Defect

Frame leaks. Adjustment deterioration and infiltration.

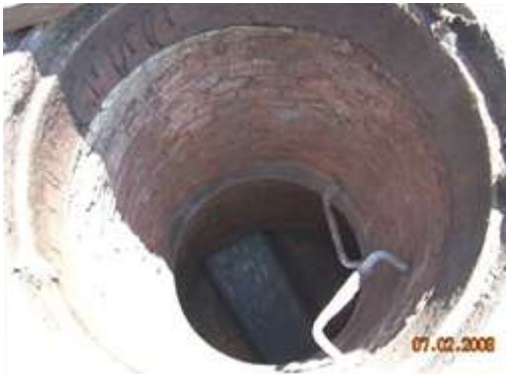
Defect

Frame leaks. Adjustment deterioration and infiltration. Corbel and Barrel infiltration.

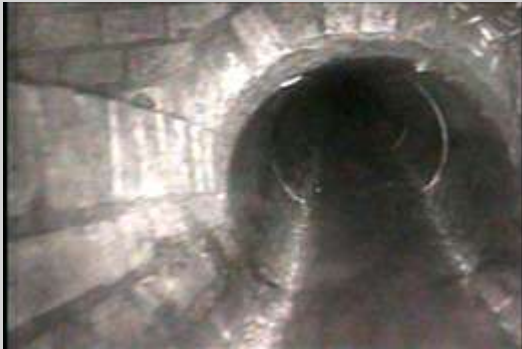
18 in. Circular Gravity Sewer Pipe Out @ 12 O'Clock

Deposits: ☐ None ☐ Mud ☐ Sludge ☐ Debris ☒ **Grease**

Silt Depth: **0** (in.) Deposits Extent: **Light**

Infiltration: **Evidence** Pipe Seal Cond: **Unknown**

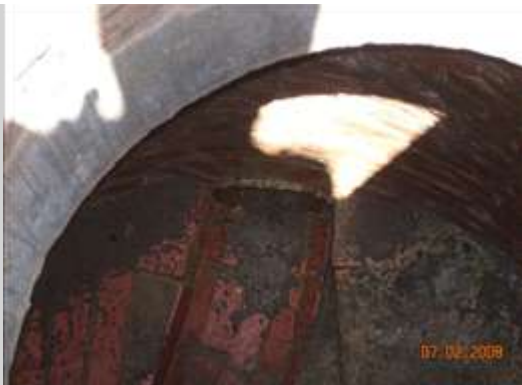
10 in. Circular Gravity Sewer Pipe In @ 3 O'Clock

Deposits: ☐ None ☒ **Mud** ☐ Sludge ☒ **Debris** ☐ **Grease**

Silt Depth: **1** (in.) Deposits Extent: **Light**

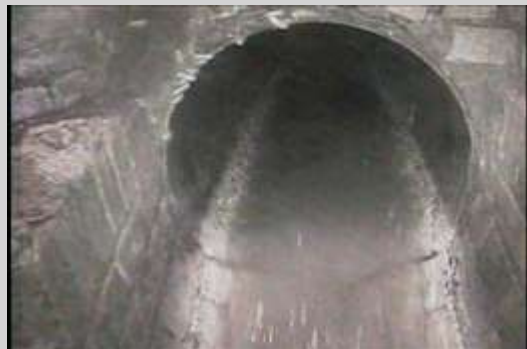
18 in. Circular Gravity Sewer

Deposits: ☐ None ☐ Mud ☐ Sludge ☐ Debris ☒ **Grease**

Infiltration: **Evidence**

Pipe Seal Cond: **Cracked**
